NASA Technical Memorandum 103760

## Matrix Plasticity in SiC/Ti-15-3 Composite

Bradley A. Lerch  
*Lewis Research Center*  
*Cleveland, Ohio*

July 1991

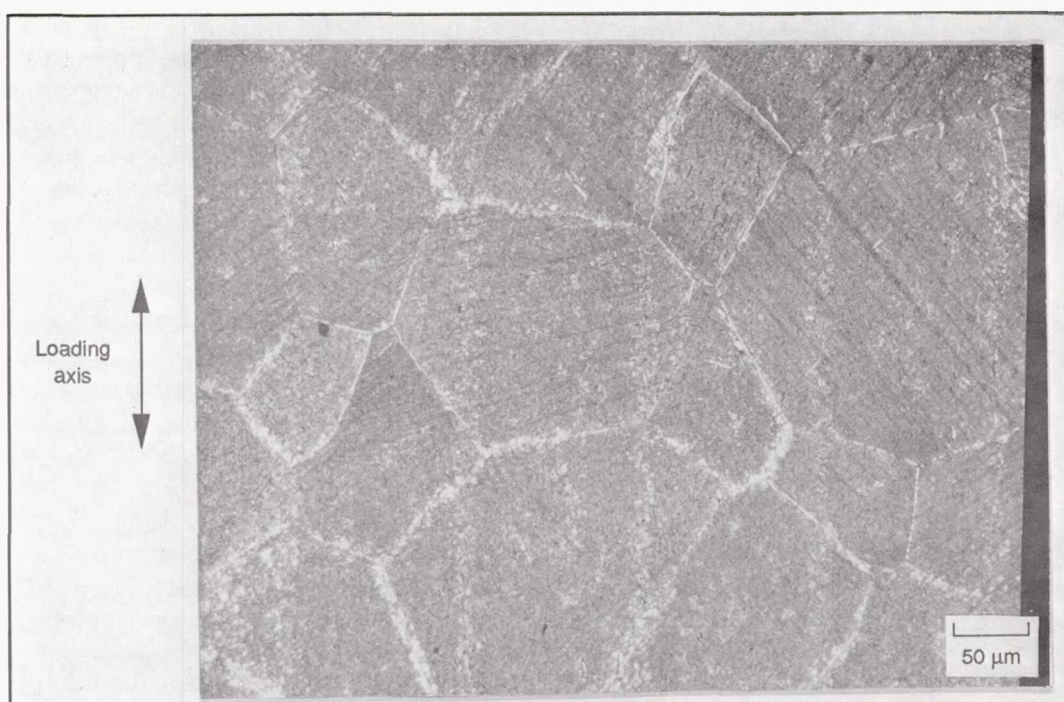
Figure 2.—Enlargement of the transition area "A" in figure 1 showing slip bands in some grains.

section and the radius shows a gradual decrease in the slip band density as the cross-sectional area of the specimen increases (fig. 1) until finally, no slip bands are observed. Enlargements of this area depict isolated slip bands in each grain (fig. 2).

This technique has not been refined to provide optimum viewing areas for identifying slip bands. The etchant used in this method is unpredictable in that the matrix background is sometimes light and sometimes very dark (see figs. 11 and 2, respectively). The dark background can be due to the precipitation of very fine alpha titanium particles which rapidly over-etch. This has been observed in both unreinforced matrix and composite specimens which were aged at similar, low temperatures (ref. 5). The dark background can also result from a very high density of slip bands. This is indicated in figure 1, in which the straight gage section, which is heavily deformed, is much darker than the radius. Here, the dark areas in which no individual slip bands are evident could be areas of very high deformation. Further work is necessary to allow discrimination between these two cases.

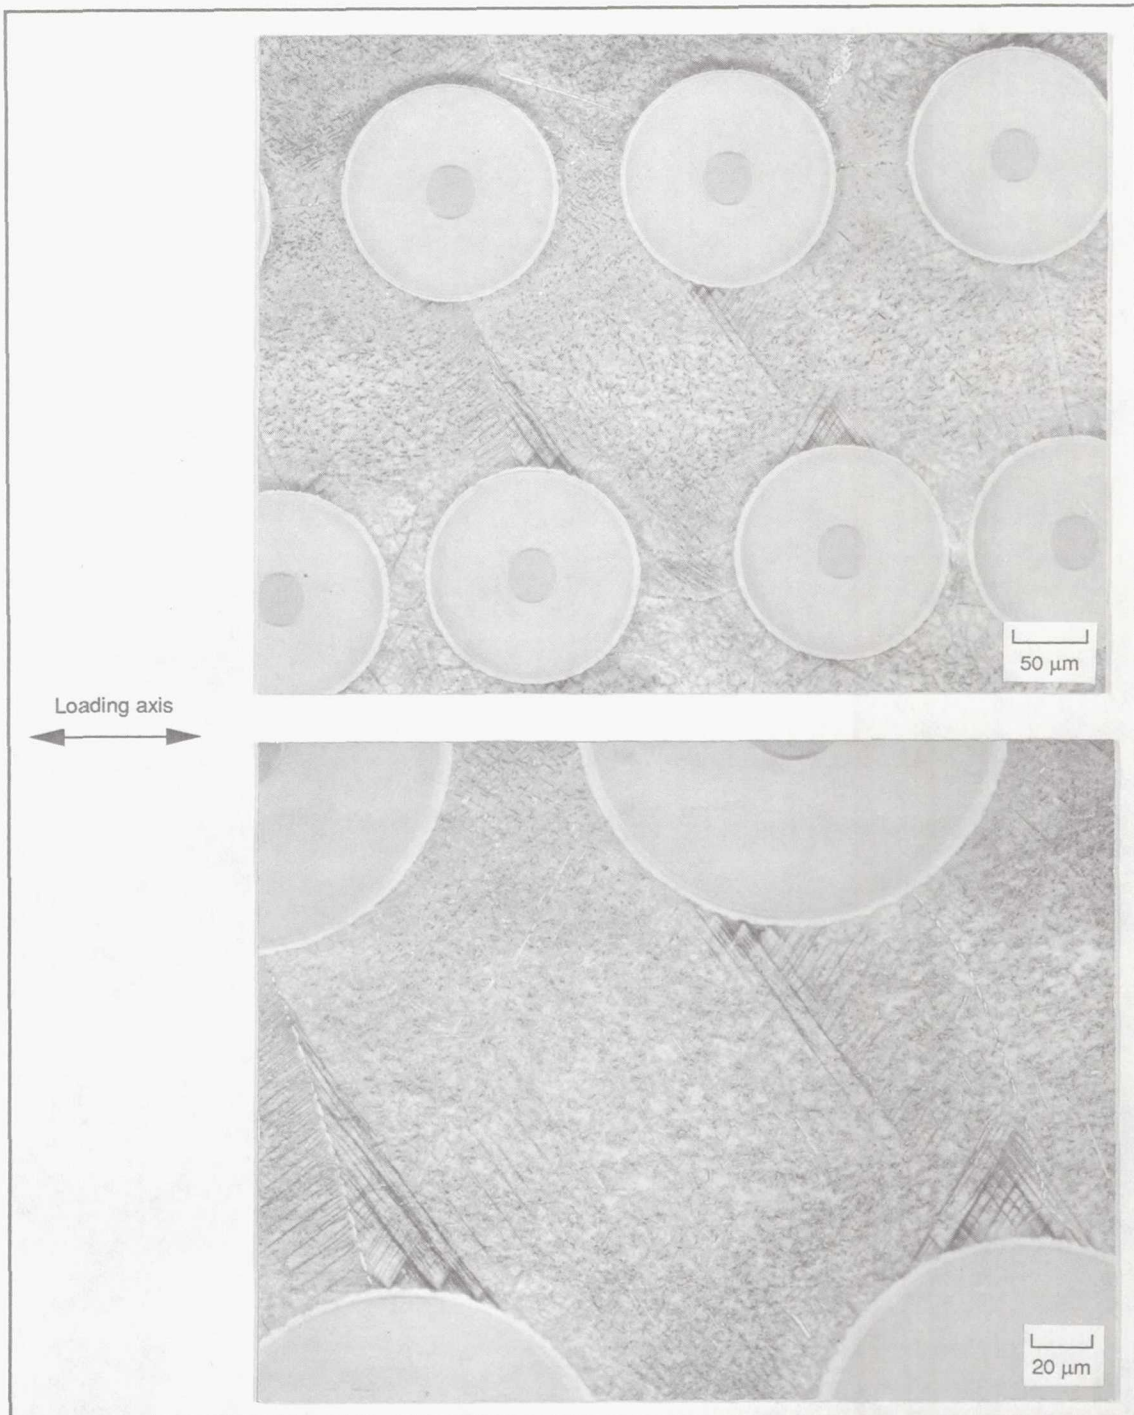
Figure 7.—Slip bands in the matrix of a  $[90^\circ]_B$  specimen which was interrupted after a tensile strain of 0.6 percent.

A  $[90]_8$  specimen was pulled in tension to a strain of 0.60 percent. The corresponding stress-strain curve (fig. 6) shows that the specimen is well into the nonlinear regime. Similar to the  $[0]_8$  specimen, a permanent strain offset is observed upon unloading, which indicates that the specimen contained some form of damage. Metallographic examination revealed the damage to consist of matrix plasticity and interfacial debonding. Figure 7 shows slip bands which occurred in this specimen. Slip is again concentrated mostly near the fibers and occurs on the portion of the circumference which is perpendicular to the load axis (i.e., at 6 and 12 o'clock in the figures). The slip bands also seem to connect fibers of adjacent plies at approximately a  $45^\circ$  angle, indicating the planes of maximum shear. Debonding of the fiber/matrix interface at several locations was also observed in this specimen, but is not shown in figure 7.
